## FAILURE ANALYSIS AND OPTIMIZATION DESIGN OF SUSPENSION SUPPORT HOLES FOR GEARBOX CASES

The suspension hole of a gearbox case was cracked after the mining test vehicle has covered 7000 km. In order to analyze and solve this problem, in this paper, based on the modal analysis of the suspension system and failure analysis of the faulty parts, the finite element model of the powertrain system was established using Ansys, and strength analysis of the gearbox case was carried out. According to the analysis results, improvement and optimization measures were proposed. The analysis results show that the maximum stress of the optimized gearbox case was reduced by 6.9%, and the test vehicle could operate for 50 000 km without failure after the improvement, which verified the effectiveness of those measures. Accumulating experience in the gearbox case design and simulation, modal analysis and finite element analysis were combined to quickly identify the failure causes of the suspension support hole, and targeted improvement measures were taken, which effectively shortened the research and development cycle and saved production costs.

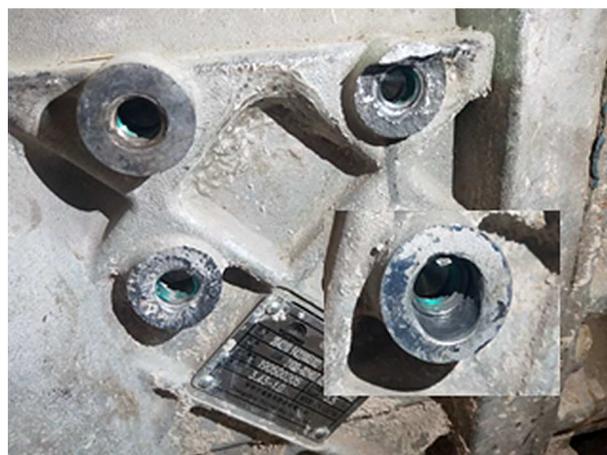
During the durability test of a pure electric mining test vehicle, when the vehicle covered 7000 km, the problem of rupture of the suspension hole of the gearbox case appeared. The inspection of the powertrain found that there were oil stains on the surface of the gearbox shell, and the support holes on the left side of the shell (flange direction) were damaged. Two support holes were broken in the middle of the screw thread, with the fracture not structurally loose. Figure 1

Fig. 1. Rupture position of the support hole

shows the lower left and upper right support holes. One support hole steel wire thread sleeve and the inner wall of the hole were damaged in the middle of the thread against the lower end. Figure 1 shows the lower right support hole. The thread of the broken support hole measured up

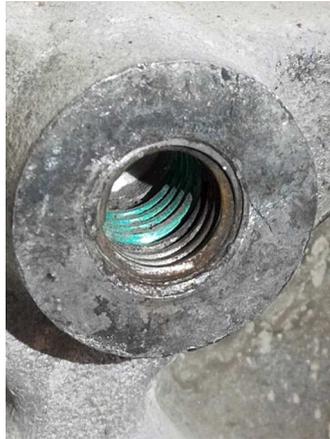
to 10 mm in depth, and the damaged support hole wall measured up to 10 mm in depth. Still, 1/2 was unscrewed as shown in Fig. 2.

Fig. 2. Support hole thread the gearbox case

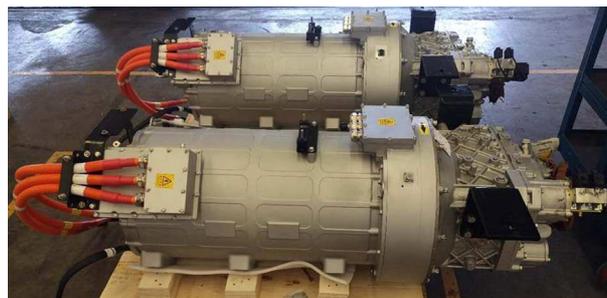
Fig. 12. Before the verification

Figures 12 and 13 show the gearboxes before and after loading verification, respectively. The improved gearbox case has successfully completed the loading test and undergone a 50 000 km road durability test, indicating that the optimized gearbox case meets the requirements of the design target.

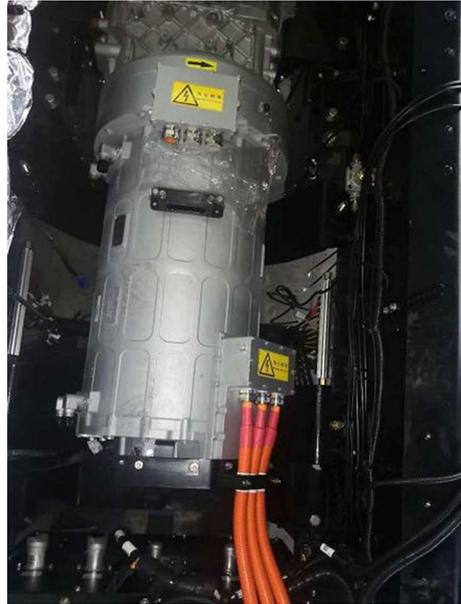
Fig. 13. Loaded status
